Technical Service Bulletin

TBJ003

Product: CXM circuit boards, ClimateMaster part number 17B0001N01

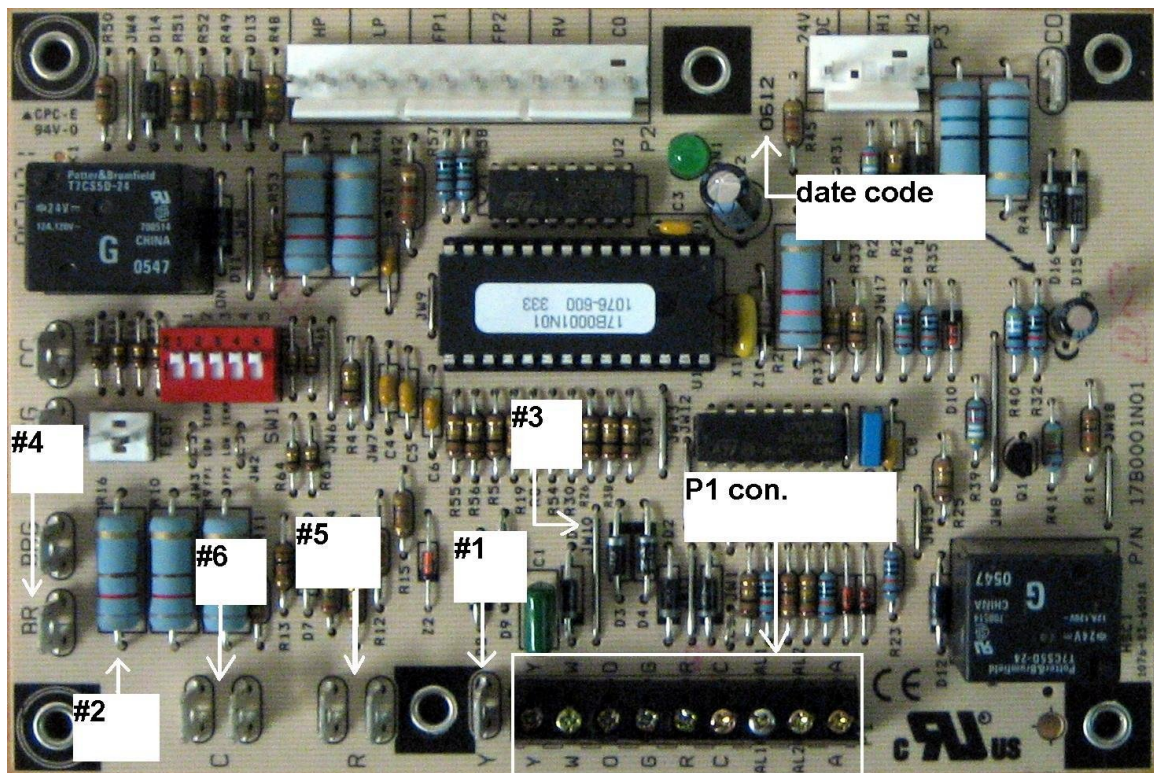
Effected Range: Units serial numbers G148****– J126****, Built: Nov 14, 2005 – June 30. Effected CXM boards will have a date code range between 0548 and 0627, see picture below for date code location. Control Board date codes are formatted as year/week, i.e. 0612 = 12th week of 2006.

- P1 “Y” to “Y” quick connect **#1 ON PICTURE**
- P1 “W” to outside lead of R16 **#2 ON PICTURE**
- P1 “O” to JW10 on control (right above “O” terminal) **#3 ON PICTURE**
- P1 “G” to “BR” quick connect **#4 ON PICTURE**
- P1 “R” to “R” terminal cluster **#5 ON PICTURE**
- P1 “C” to “C” terminal cluster **#6 ON PICTURE**

If continuity is measured during these above tests, the P1 connector is not a problem. If Y, R, G or C fail to measure continuity, temporary repair can be made by removing those wires from the P1 connector and attaching them directly to the corresponding $\frac{1}{4}$ " spade terminals on the circuit board. If W or O fail to measure continuity, the board can not be field repaired and must be immediately replaced. If replacement of the control board is necessary, normal warranty guidelines apply.
