Technical Service Bulletin

TBJ003

Product: CXM circuit boards, ClimateMaster part number 17B0001N01

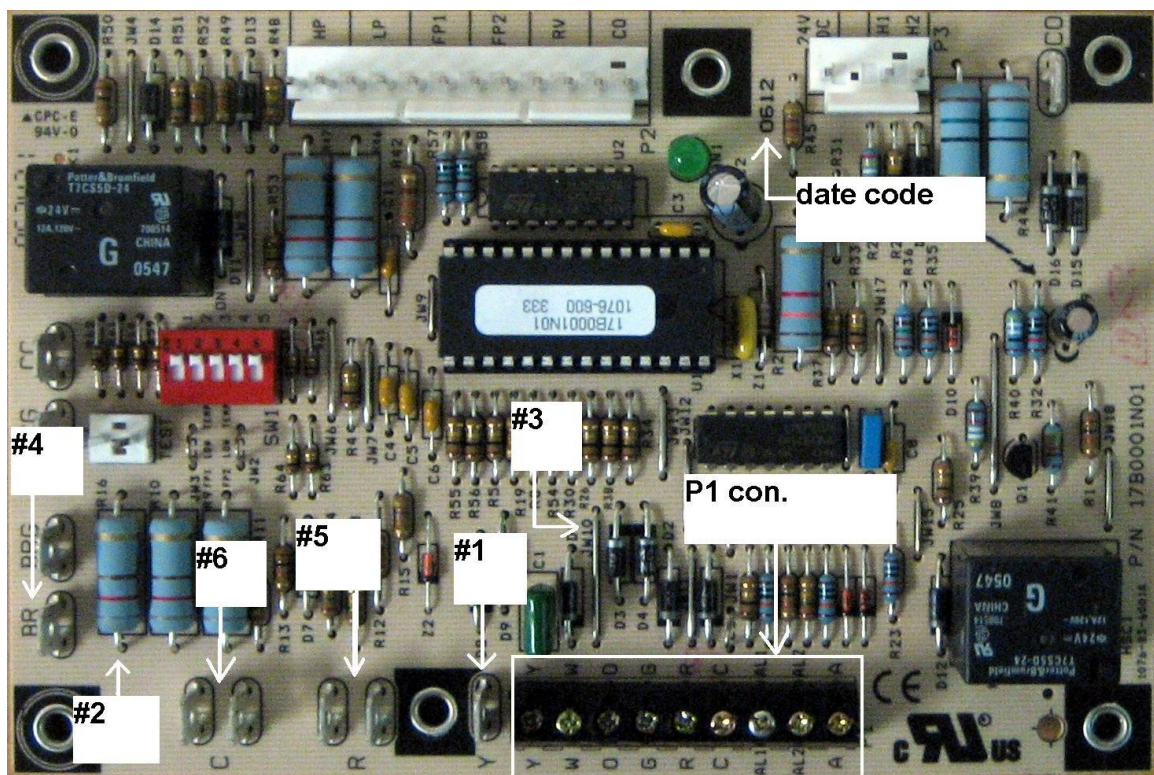
Issue: An abnormally high failure rate of the P1 connector (where the thermostat wires attach) has occurred on CXM boards utilized in the Effected Range of units noted. The P1 solder connections to the CXM board can break loose if excessive torque is applied when connecting thermostat wires into the screw terminals resulting in loss of one or more of the thermostat signals to circuit board. The signal loss may be 100% or intermittent. With this loss, certain modes or components of the unit will not function normally, although the green CXM status light is on and no fault is displayed. Because the loss of connection is between the P1 connector and the board, it may be possible to measure a thermostat control signal at a screw terminal even though it is not making a connection through the board and on to the unit.

- P1 “Y” to “Y” quick connect **#1 ON PICTURE**
- P1 “W” to outside lead of R16 **#2 ON PICTURE**
- P1 “O” to JW10 on control (right above “O” terminal) **#3 ON PICTURE**
- P1 “G” to “BR” quick connect **#4 ON PICTURE**
- P1 “R” to “R” terminal cluster **#5 ON PICTURE**
- P1 “C” to “C” terminal cluster **#6 ON PICTURE**

If continuity is measured during these above tests, the P1 connector is not a problem. If Y, R, G or C fail to measure continuity, temporary repair can be made by removing those wires from the P1 connector and attaching them directly to the corresponding ¼” spade terminals on the circuit board. If W or O fail to measure continuity, the board can not be field repaired and must be immediately replaced. If replacement of the control board is necessary, normal warranty guidelines apply.
